**Thatcham Accredited Parts Validation**  
**Crash Tests –**  
**The Question of Safety**

## 1. Introduction.

In order to support the claim that Thatcham Accredited Parts do not compromise the occupant protection levels offered by modern vehicles it was decided to compare the crash performance a new car with two others fitted with replacement parts. Since the current Euro NCAP 64 Km/h frontal crash is widely regarded as the most severe safety test currently undertaken it was selected to compare the performance of a “good” scoring vehicle with two identical used vehicles, one fitted with Thatcham Accredited Parts, the other with the VM’s own after market panels.

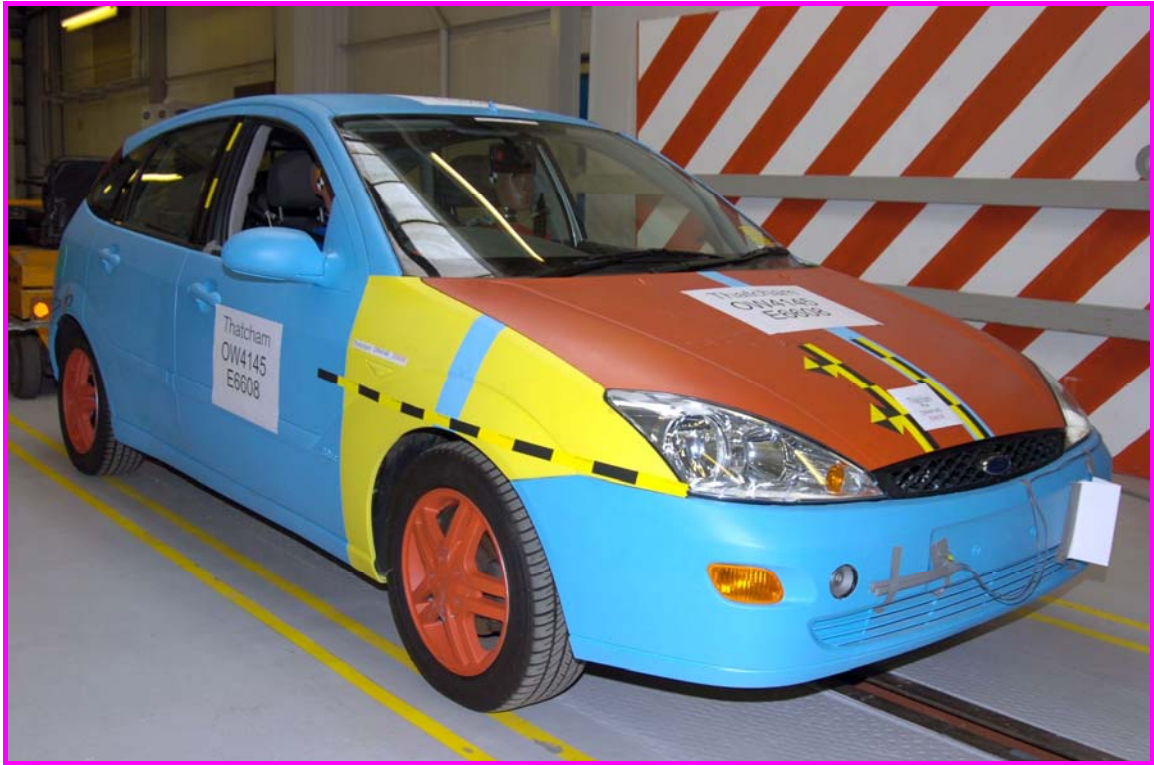
*Figure 4 Thatcham accredited Pre test*

Both vehicles were subsequently rebuilt with either Thatcham accredited parts or Ford OEM aftermarket parts. Each vehicle was rebuilt to OEM standards and was visually identical. Each supplanted component was painted in a contrasting colour to make identification easier along with the rest of the vehicle which was painted in a standardised overall blue. The steering geometry was checked on both vehicles and both weighed. Due to variation in specification and wheel types a small amount of ballast was introduced to ensure that both vehicles were tested to an identical mass of 1384 kg (including test devices).

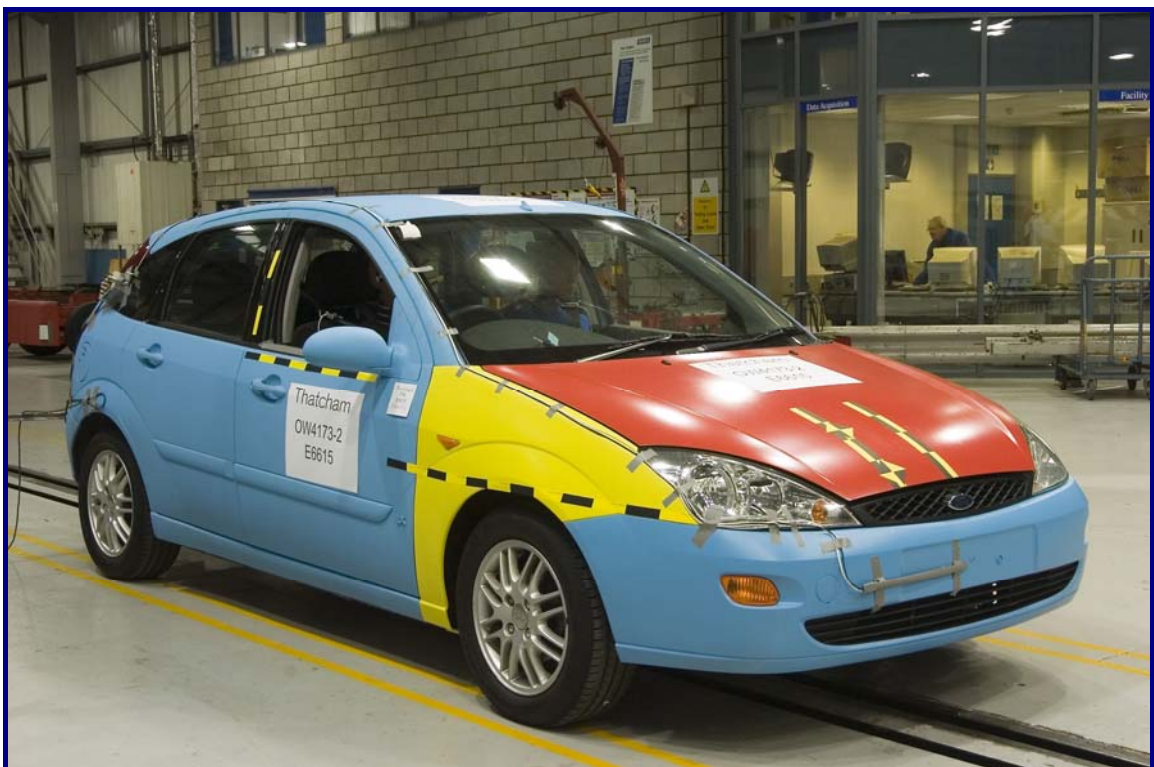
*Figure 5 OE Pre test*

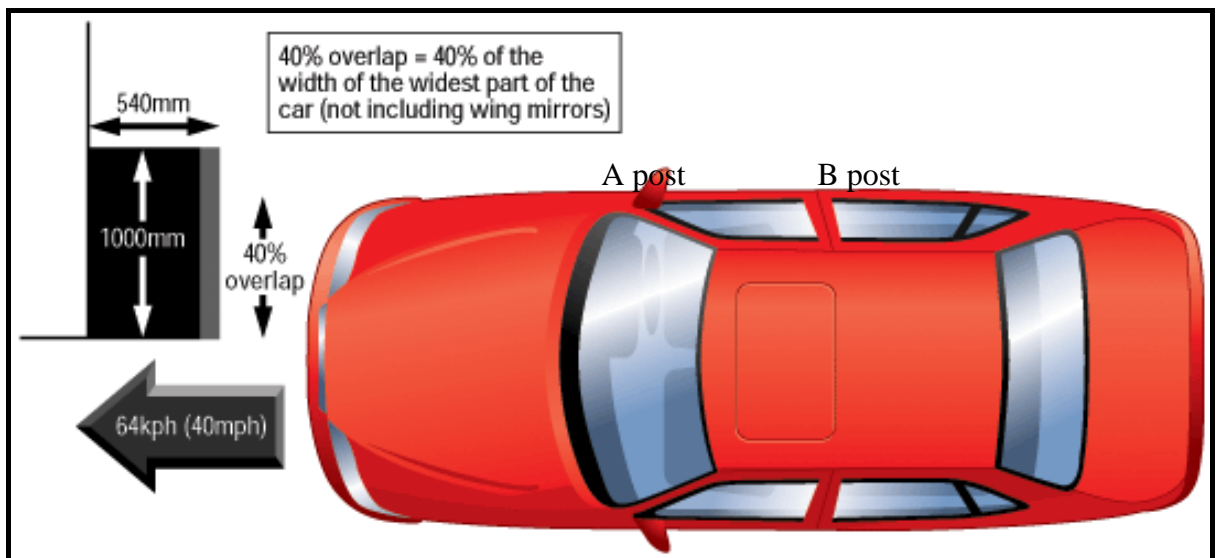
Figure 1.

Since the most stringent regulatory frontal crash test (ECE R94) is run at only 56 Km/h (35 mph) it was decided to undertake these Thatcham Accredited Parts Crash Tests to the more stringent Euro NCAP consumer test procedure. The Euro NCAP frontal impact test is conducted at 64kmh (40mph) representing 29% more energy than the legal requirement, offset to 40% of the vehicles width on the drivers side, see figure 1 below. The impact is run into a standardised EEVC aluminium honeycomb barrier representing the structure of a similar vehicle. The test is typically conducted on the highest volume selling derivative in the European market.

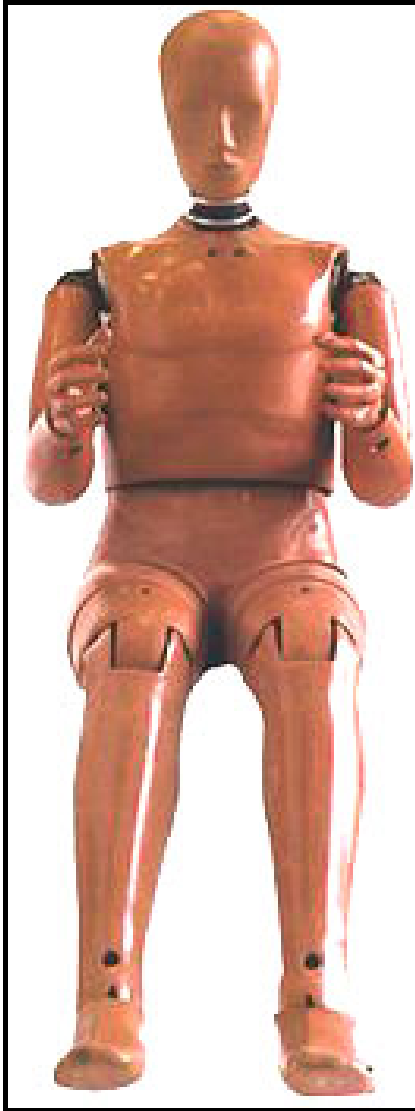
*Figure 2*

front seats. (Figure 2 ). These crash test dummies are as biofidelic as technology currently allows and can accurately record forces and accelerations typical of a magnitude that has been shown to be injurious. The head is made of aluminium and covered in rubber 'flesh'. Inside, three accelerometers are set at right angles, each providing data on the forces and accelerations to which the brain would be subjected in a crash. The neck (figure 3) features measuring devices to detect the bending, shearing and tension forces on the neck as the head is thrown forwards and backwards during the impact. Neither arm carries any instrumentation. The Hybrid 3's steel ribs are fitted with equipment that records deflection of the rib cage in the frontal impact since injuries can occur where forces exerted on the chest, such as from the seat belt are in excess of biomechanical limits. Load cells in the femur and legs provide data in frontal impacts on likely leg, hip and pelvis fractures. A 'knee slider' is used to measure forces transmitted through the dummy's knees, particularly if they strike the lower fascia. Lower Leg Instruments fitted inside the dummies' legs measure bending, shear, compression and tension, allowing injury risks to the tibia (shin-bone) and fibula (connecting knee to ankle) to be assessed. Assessment of feet and ankles injury risk in the frontal impact is made by measuring distortion and rearward movement of the driver's footwell area.

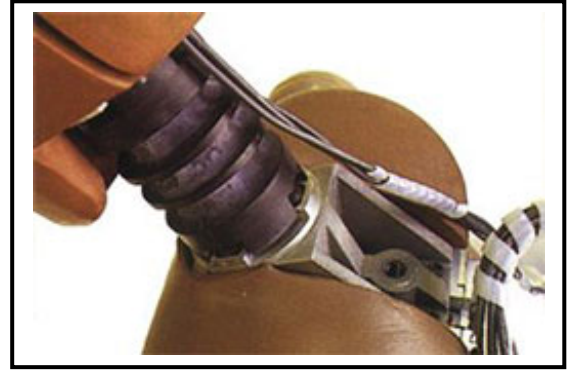
*Figure 3*

In order to absorb the energy of the crash a vehicle manufacturer must design the vehicle in such a way to allow the distortion and bending of the structure. However this distortion must not encroach into the occupant compartment or the survival space of the passengers may be compromised. In order to measure this distortion a number of static measurements are taken with a CMM device (Coordinate Measuring Machine) that allows an assessment to be made of structural distortion and intrusion pre and post crash.

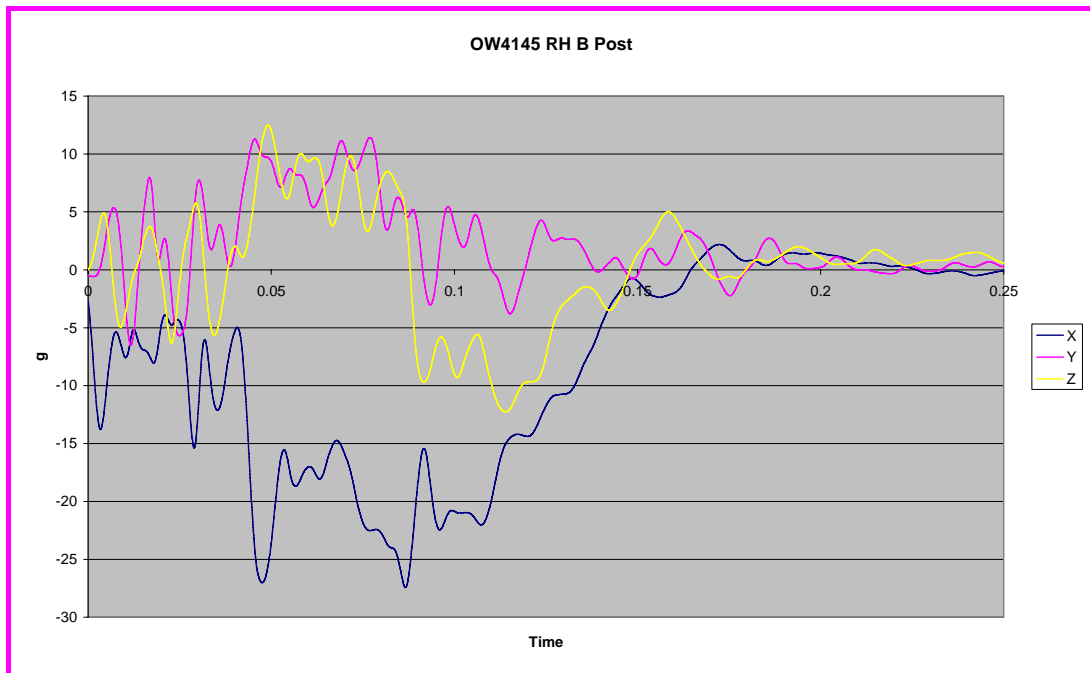
Graph 1. Three axis struck side B post base for TA vehicle. The data has been filtered to CFC 60 to remove excess noise and give a clearer picture of the underlying pulse.

The following graphs show the comparative structural time histories of the two Thatcham test cars taken at the lower B-Pillar and centrally placed airbag module.

Analysis of the time histories of both vehicles show very similar loading conditions with no meaningful difference in the vehicles structural performance.

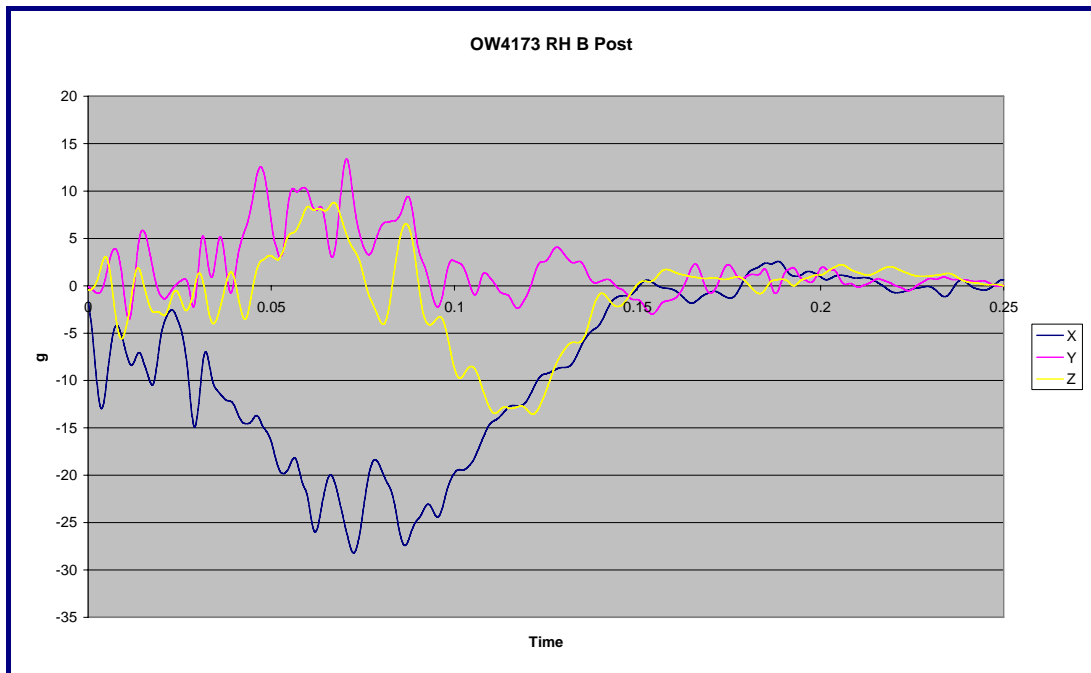
Graph 2. Three axis struck side B post base for OE vehicle. The data has been filtered to CFC 60 to remove excess noise and give a clearer picture of the underlying pulse.

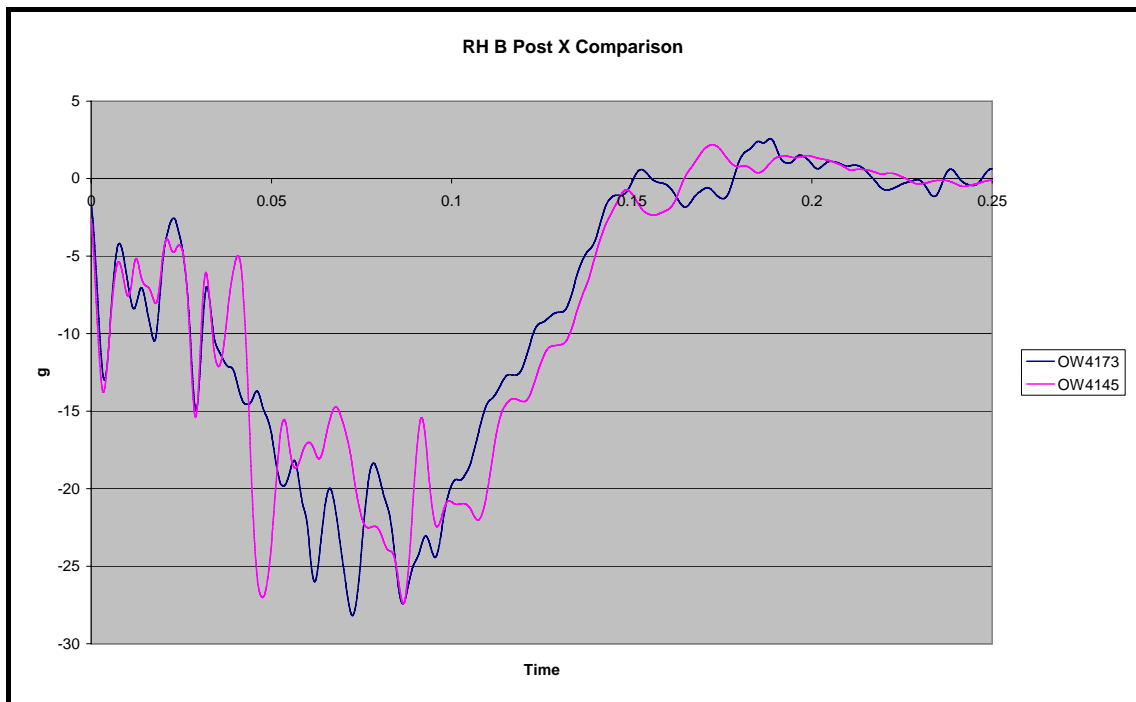
Graph3. X channel from both tests overlaid for easier comparison. The correlation between the two is evident.

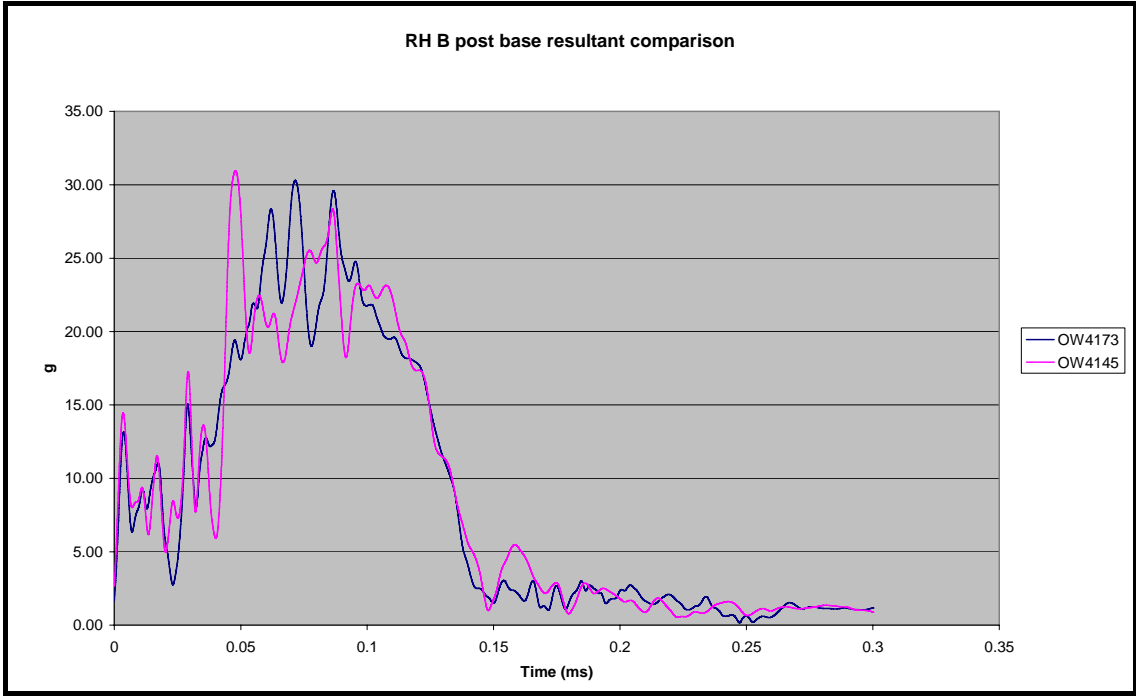
Graph4. Resultant accelerations from the B post traces overlaid. Overall there is a good correlation between the two pulses.

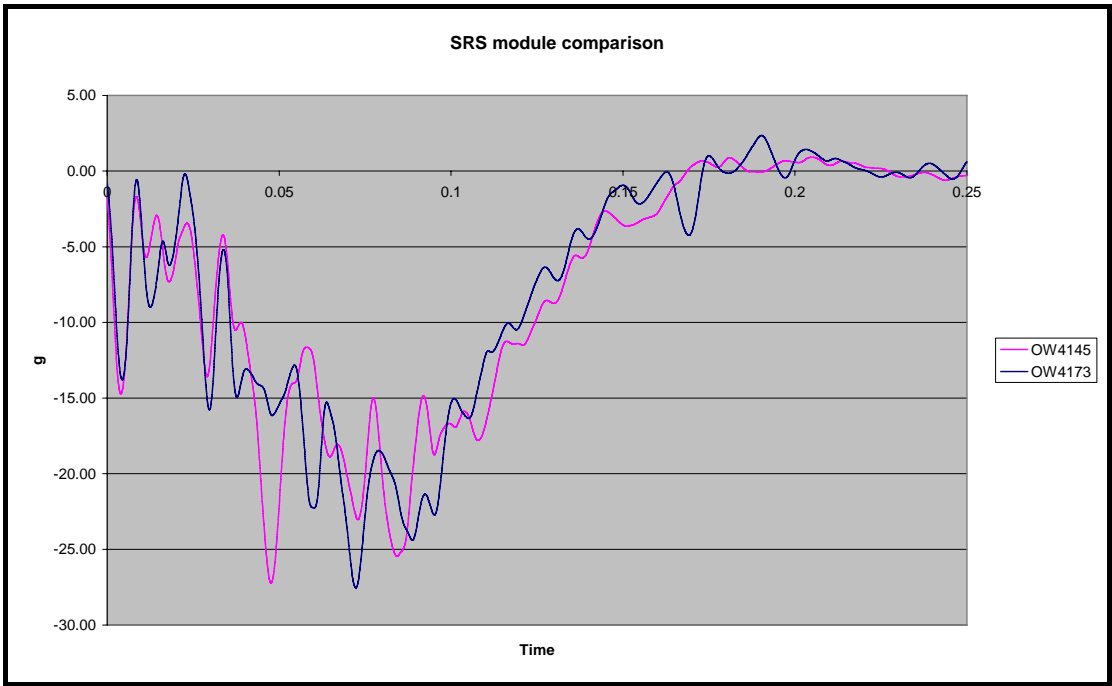
Graph 5. Airbag ECU comparison

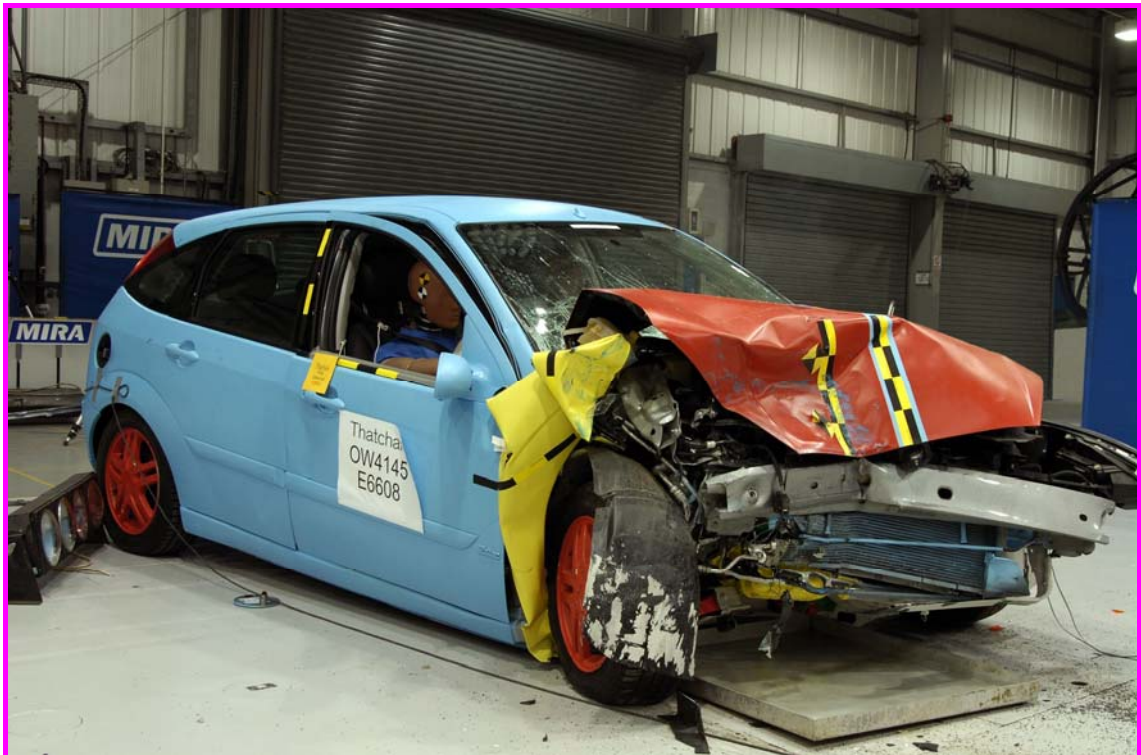
The following photographs show the comparative residual structural deformation after the two crash tests. Detail shots illustrate the wheel to sill loading condition and the bonnet windshield intrusion. Note should be made of the identical fold initiation of the two bonnets at the windshield area indicating identical structural performance.

*Figure 6 Thatcham accredited Post test.*

The test results indicate that there was no meaningful structural performance difference between these two Ford Focus'. The age, specification and configuration of the two cars test weights and impact speeds were almost identical. Analysis of the visual material shows both vehicles have a stable structure that engages the barrier at a similar point with crush being initiated at similar points and within milliseconds of each other. The deformation of each vehicle follows a similar pattern with the same OSF wheel loading trait in the sill area and similar crush to the wing and door structure. The bonnet initiation points for both TA and OE are identical, both protecting the occupant from windshield intrusion. The A pillar structure remained stable with a small amount of distortion to the cant rail and door aperture area being visible on both vehicles – a similar distortion level as seen on the original Euro NCAP reference vehicle.

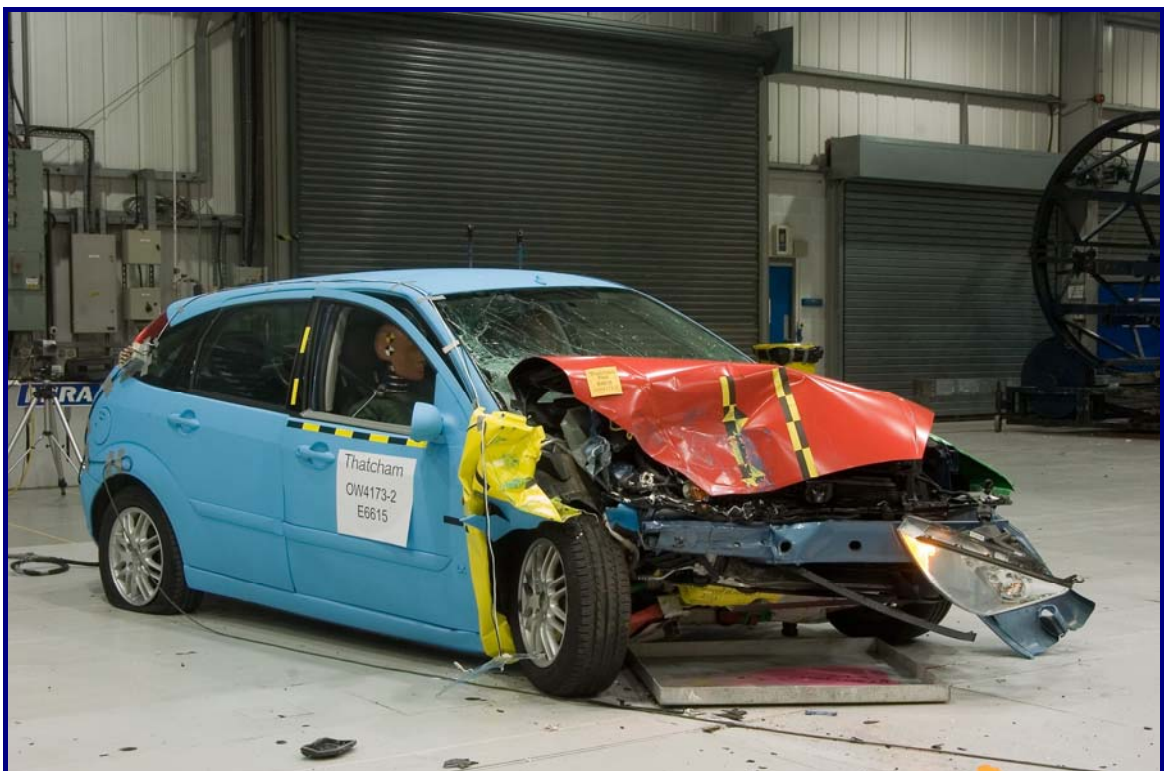
*Figure 7 OE Post test*

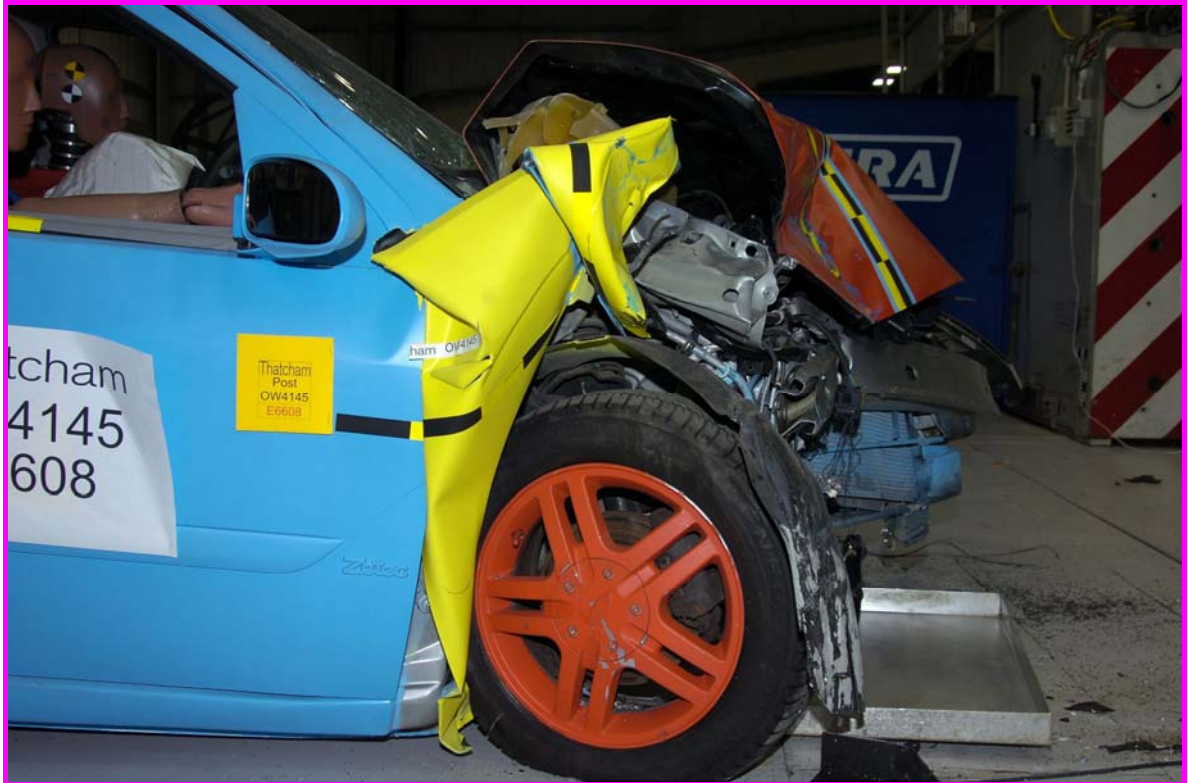
*Figure 8 Thatcham accredited detail*

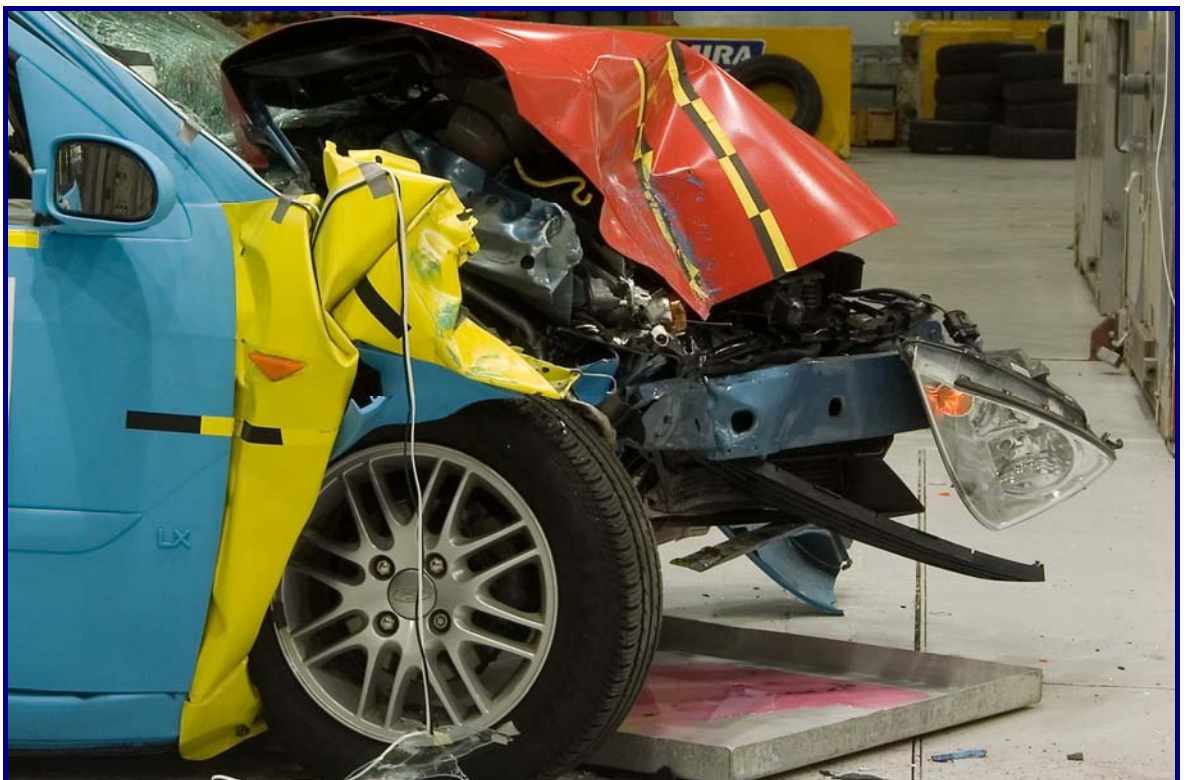
*Figure 9. OE detail*

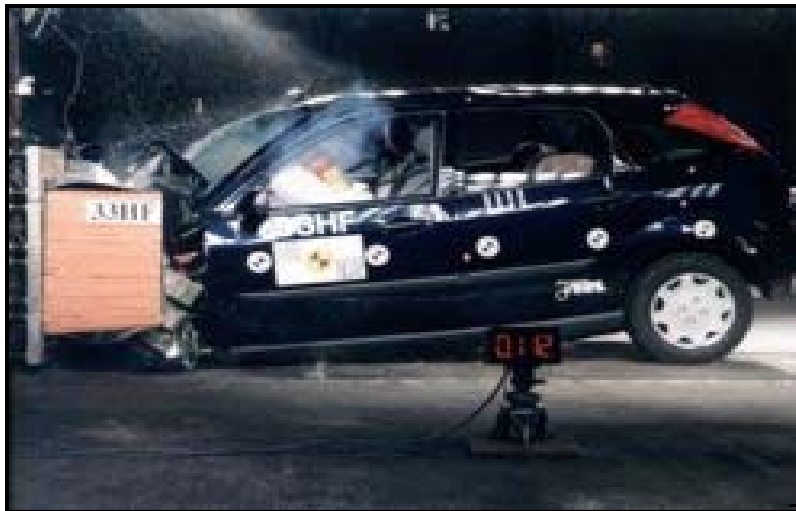
Two pictures taken from the high speed video cameras show the maximum dynamic crush and occupant ride down into the restraint system.

*Figure 10. Euro NCAP LHD Reference vehicle at maximum intrusion*

Figures 10 and 11 show both vehicles at maximum intrusion of 128 milliseconds for the Thatcham accredited, and 123 milliseconds for the OE fitted vehicle. Stable airbag contact is observable.

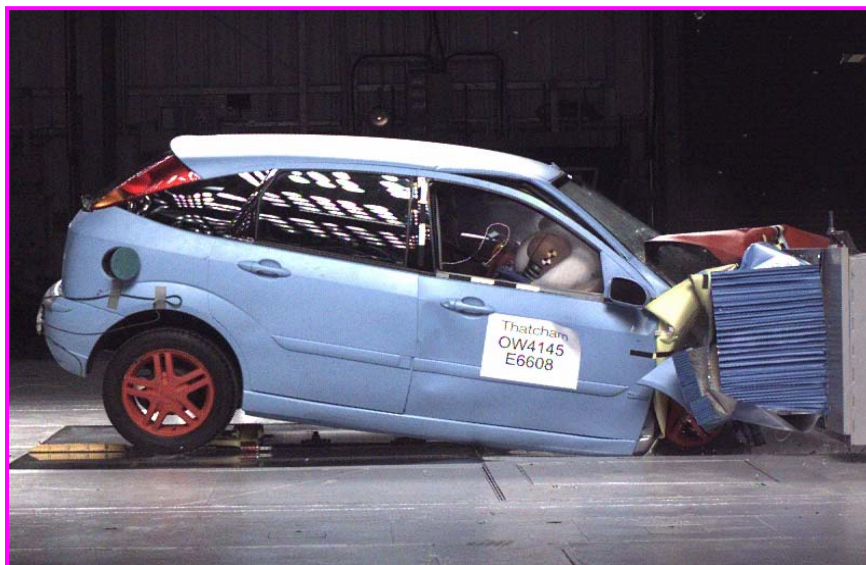
*Figure 11. Thatcham AP vehicle at Maximum intrusion*

Analysis of the restraint system shows that both vehicles airbags deployed consistently and remained stable with both drivers riding down into the airbags in a controlled manner. Steering column intrusion was similar for both vehicles and ensured to correct deployment of the restraint system.

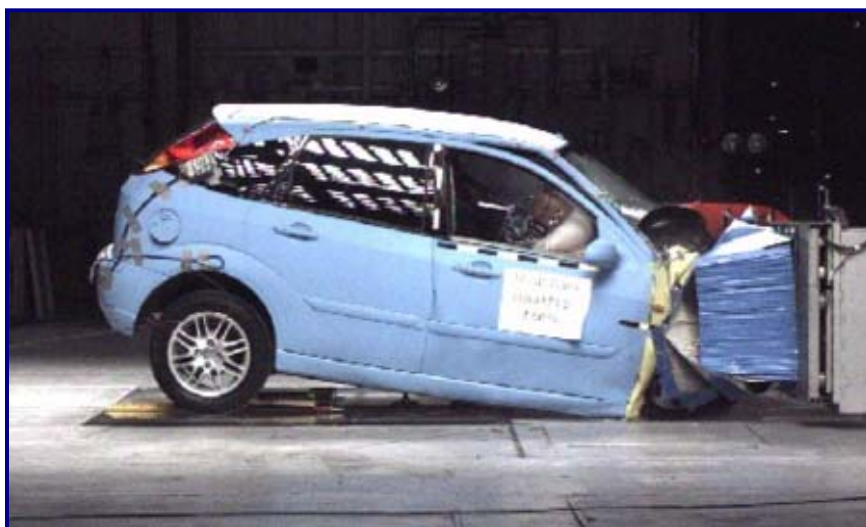
*Figure 11. OE fitted vehicle at maximum intrusion*

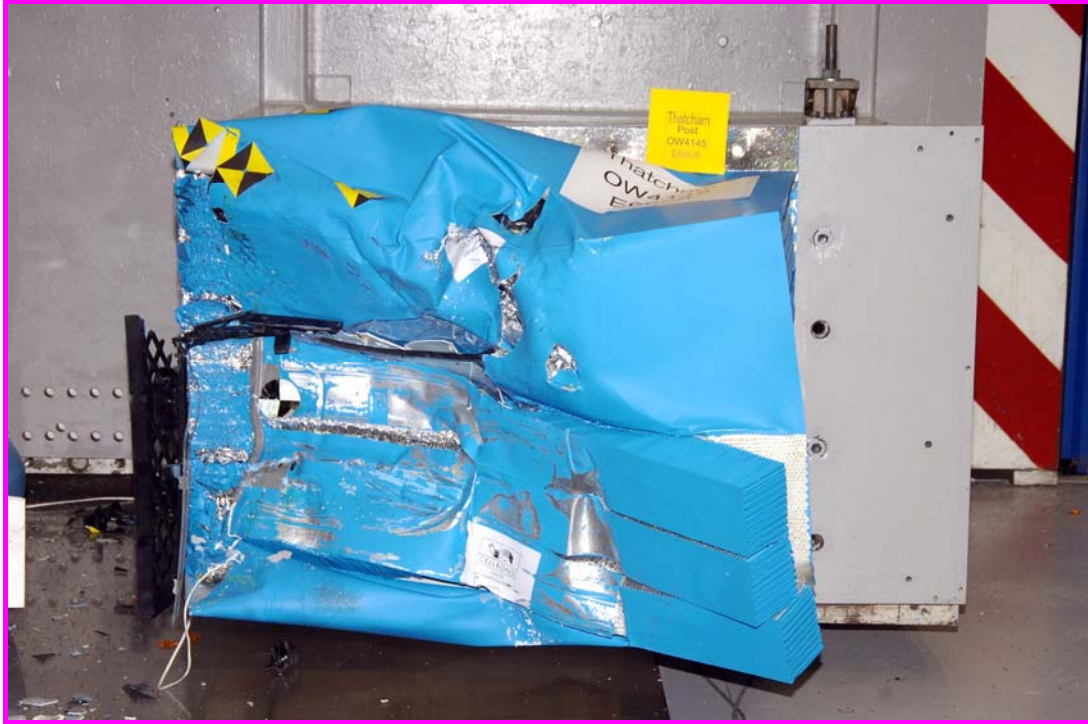
*Figure 12. Deformable element OW4145*

Figures 12 and 13 are post impact photographs of the deformable elements, they show similar patterns of damage.

Pictures also illustrate the deformation pattern against the aluminium honeycomb barriers and show the vehicles comparative stiffness and intrusion performance.

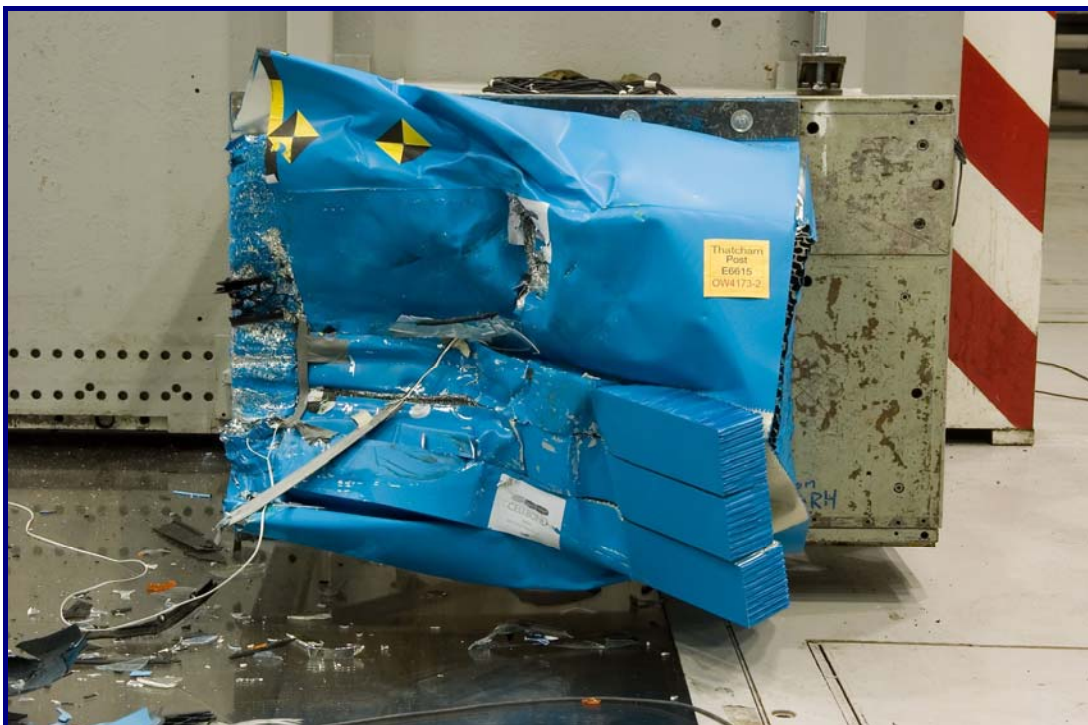
*Figure 13. Deformable element OW4173*
